Historic Structures Report
Architectural & Historical Data Section

Clubhouse, Brown Cottage, Moorhead Cottage,
and Clubhouse Annex

**SOUTH FORK FISHING
& HUNTING CLUB**

By
Landmarks Design Associates, Architects
and
Wallace, Roberts & Todd

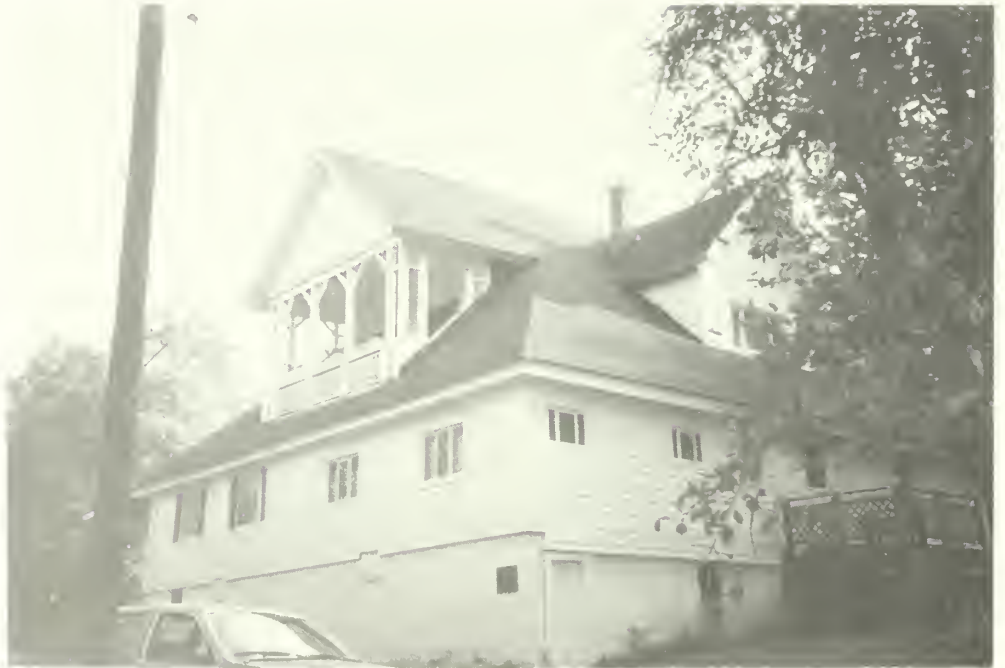
Photo E-2 East elevation of Cottage No. 2.
1992

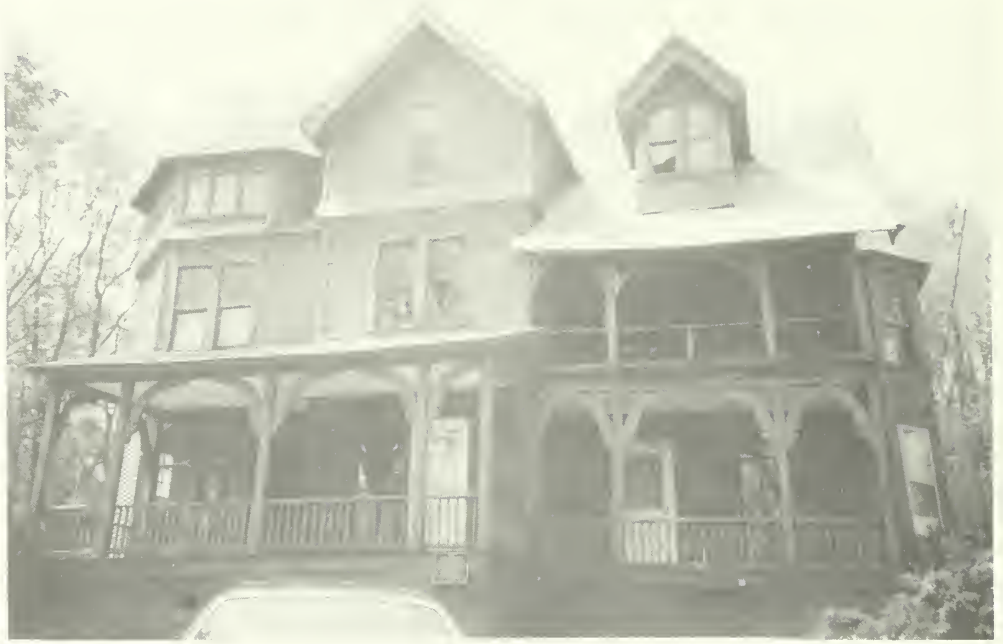
Photo E-60 East elevation.
Moorhead Cottage 1992

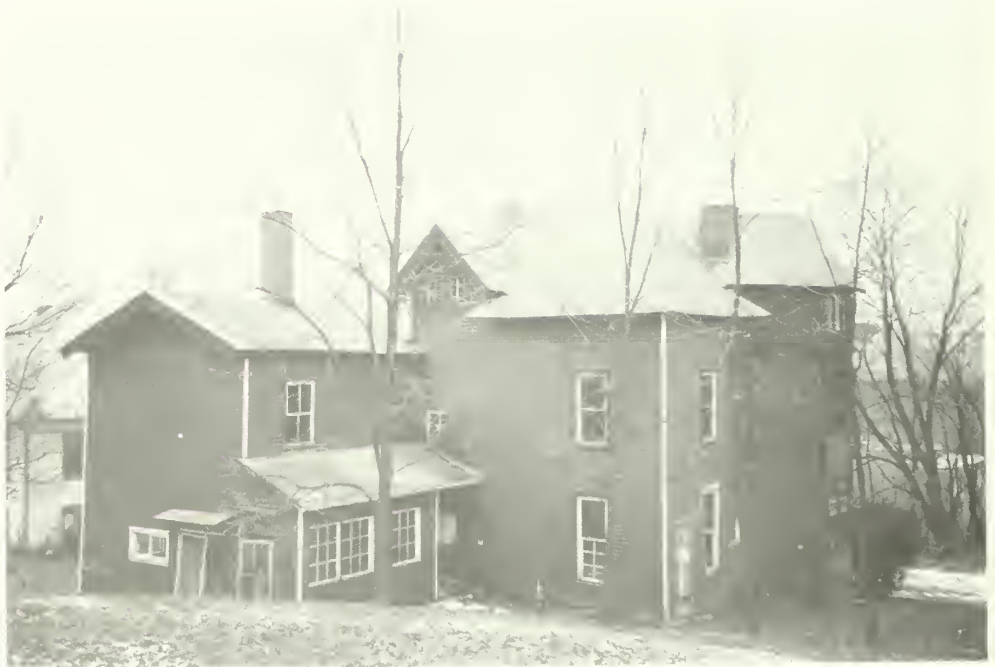
Photo E-61 West elevation.
Moorhead Cottage 1992

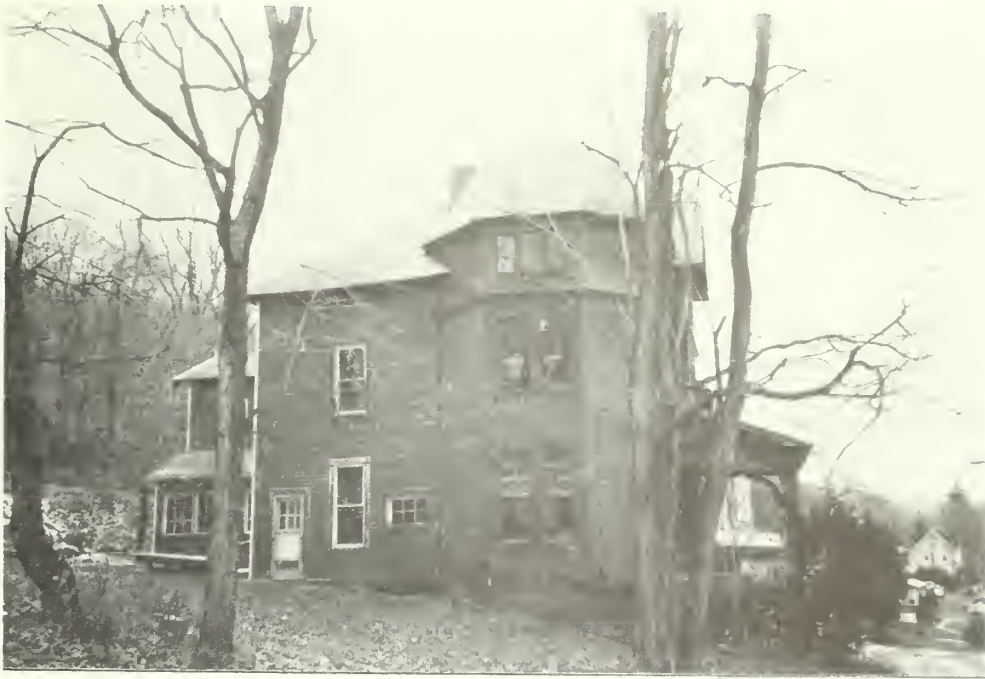
E-62 South elevation.
Moorhead Cottage 1992

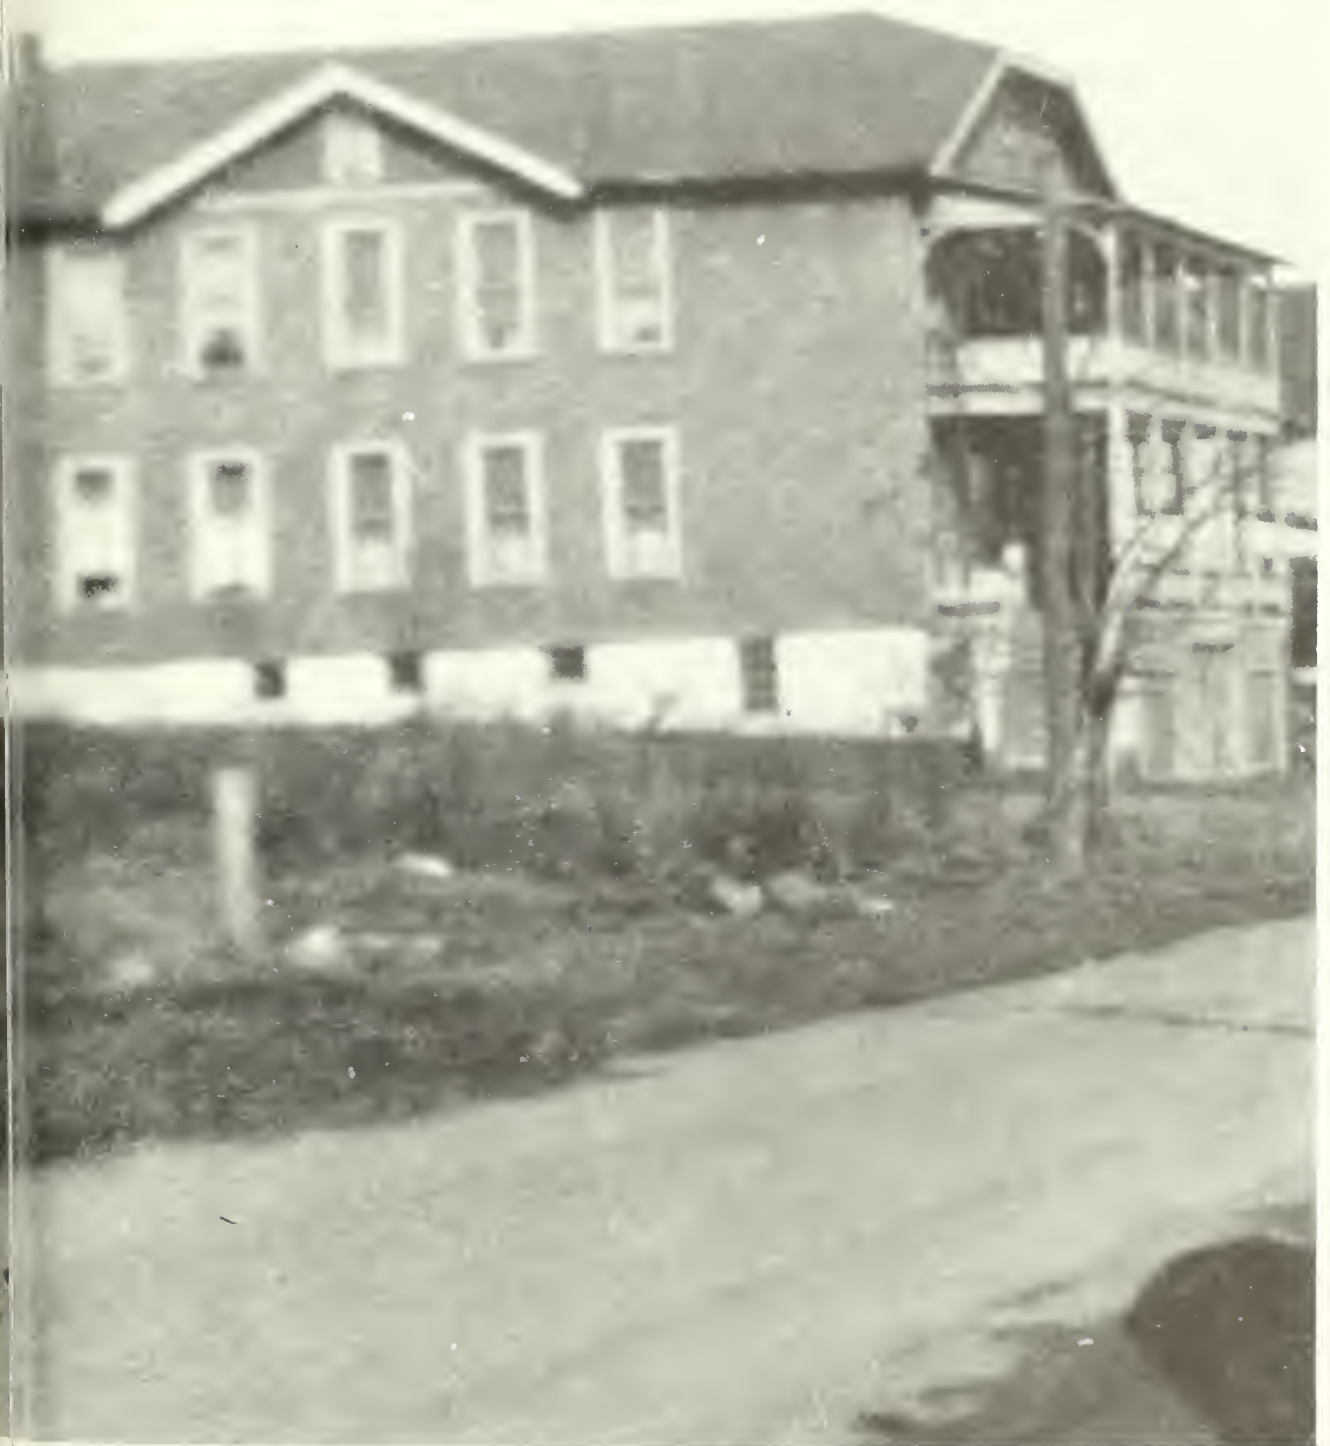
Photo H-13

**Two-story outhouse once attached to the west facade of the Clubhouse Annex
Photograph from the collection of the 1889 South Fork Fishing and Hunting Club
Historical Preservation Society**

This outhouse, believed by many to have been attached to the main Clubhouse building, was specifically recalled by two former St. Michael residents as having been attached to the west facade of the Annex. Janet Cruikshank Hoffman, whose family owned both buildings from 1921 to 1950, has an additional photo of the outhouse, but she has been unavailable to provide access to it. According to Mrs. Hoffman, the outhouse was fitted with terra cotta pipes.
